COMMONWEALTH OF PENNSYLVANIA
Department of Environmental Protection
August 23, 2011

SUBJECT: Aquatic Biological Investigation
Laurel Lake Creek (DEP Stream File #31899)
Silver Lake Twp., Susquehanna County

Introduction

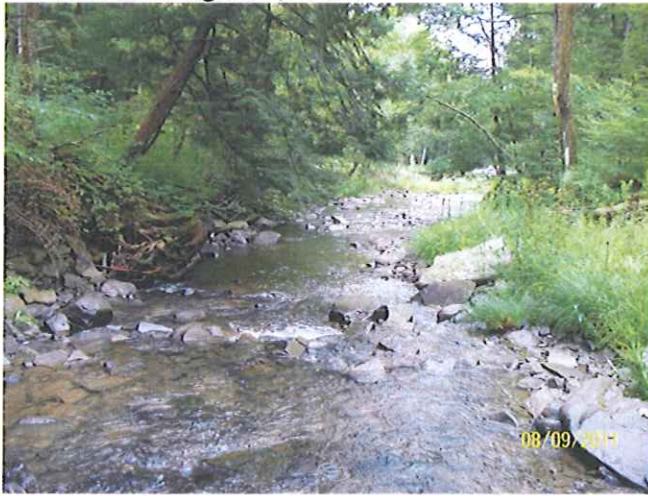
Figure 2. Photo of Laurel Lake Creek looking downstream at the reference location (Ref-1). Silver Lake Township, Susquehanna County. Photo taken August 9, 2011.

The reference site (Ref-1) was located approximately 570 feet upstream of the IRTS location (Figures 2 and 3) and the study site (Imp-1) was located approximately 530 feet downstream of the IRTS location (Figures 4 and 5).

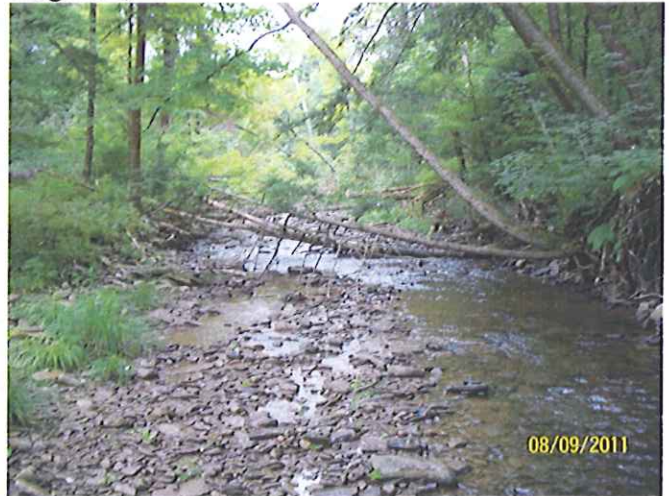
Figure 3. Photo of Laurel Lake Creek looking upstream at the reference location (Ref-1). Silver Lake Township, Susquehanna County. Photo taken August 9, 2011.

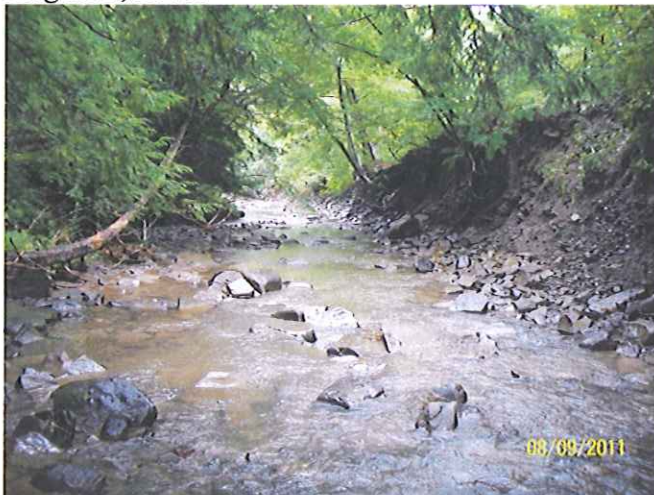
Figure 4. Photo of Laurel Lake Creek looking downstream at the study location (Imp-1). Silver Lake Township, Susquehanna County. Photo taken August 9, 2011.

Conditions at the time of sampling were intermittent periods of light rain. Stream flow was normal for this time of year. Water clarity was noticeably better at the upstream reference site than the downstream study site, presumably due to ongoing in-stream work by the directional boring subcontractor commissioned by Laser to accomplish the HDD bore.

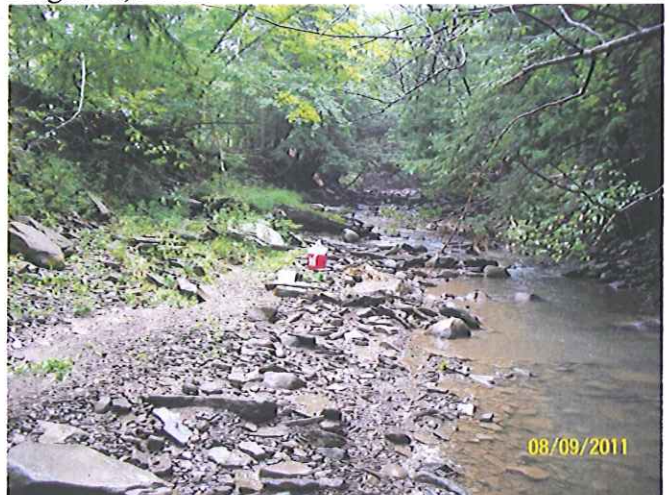
Figure 5. Photo of Laurel Lake Creek looking upstream at the study location (Imp-1). Silver Lake Township, Susquehanna County. Photo taken August 9, 2011.

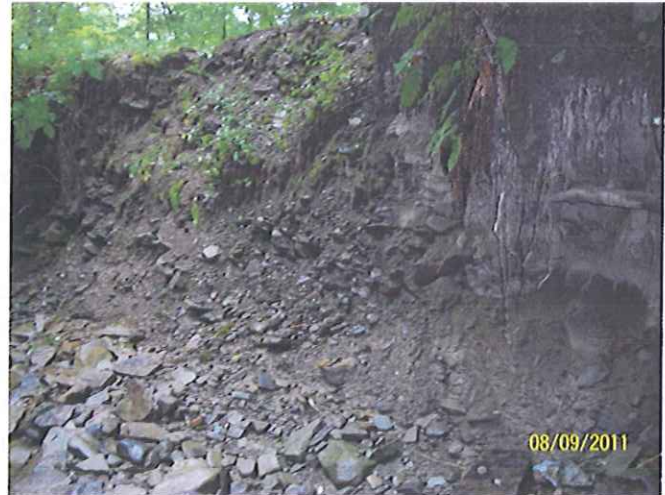
Habitat values were similar for both sites, with the exception of Embeddedness, Channel Alterations, Condition of Banks, Grazing or Disruptive Pressure, and Riparian Vegetation (Table 2). These metrics differed due to the influence of the township road disturbance near to and paralleling the stream. A large earthen mound, presumably side-cast material from the road excavation, forms the right bank of the stream at Imp-1 and is heavily eroded (Figure 6).

Figure 6. Photo of side-cast earthen mound on the banks of Laurel Lake Creek looking Southwest at the study location (Imp-1). Silver Lake Township, Susquehanna County. Photo taken August 9, 2011.
